Rigging Condition Report

Vessel Name: A Yacht
Vessel Type: Elan 410
HIN: S1-ELA41E01A2013

Mast: Selden NMP C242
Boom: Selden SLR B171

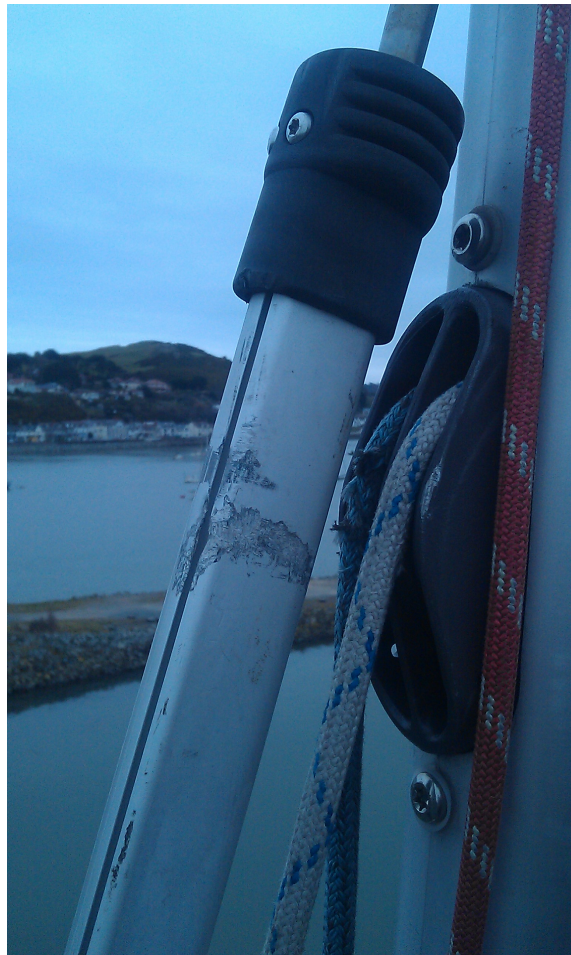
Fig. 1.1

1. There appears to be wear on the top extrusion of the furling system due to contact with the genoa halyard exit box. This is causing damage to both the sheave box and the furling extrusion -as seen in *Fig.1.1*- along with damage to the Jib halyard.

This may be due to a lack of backstay tension during the furling operation along with an inherent lack of tolerance in the build specification of the mast.

While furling and unfurling the headsail, ensure sufficient tension is maintained on the forestay via the backstay tensioner. Check regularly for any increase in damage to the foil or halyard. Should this not suffice then a more permanent solution will need to be sought.

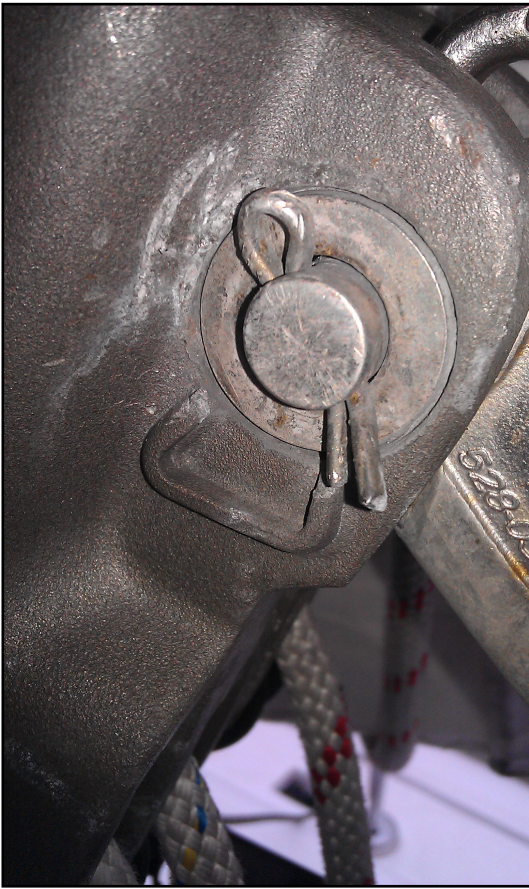
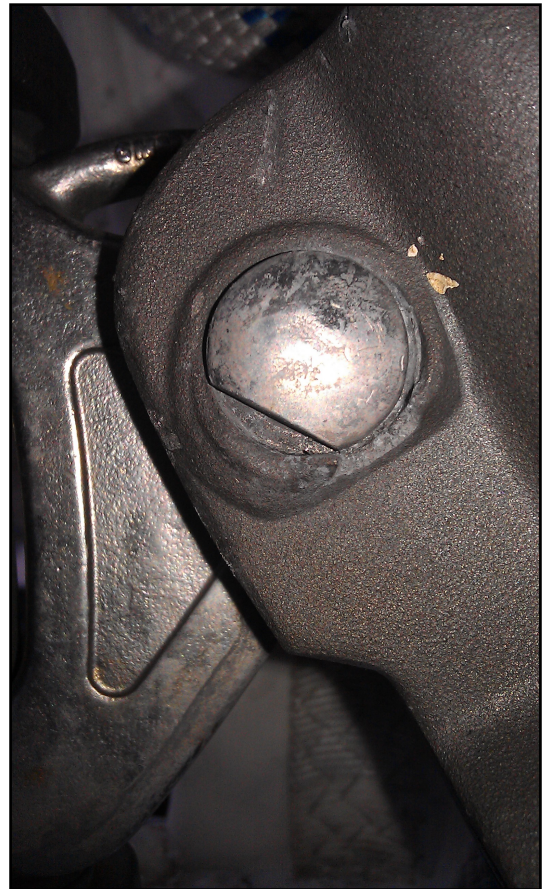
2. It was noted that the 'gooseneck' casting is slightly damaged in the area of the toggle clevis pin - as can be seen i. *Fig 2.1 and 2.2* - and most likely caused by frequent heavy tacks and gybes associated with a vessel of this type.

Regular inspection -before, during and after each sail- of the casting around the gooseneck clevis pin would be prudent. Failure in this area can potentially cause far greater associated damage to both vessel and crew.

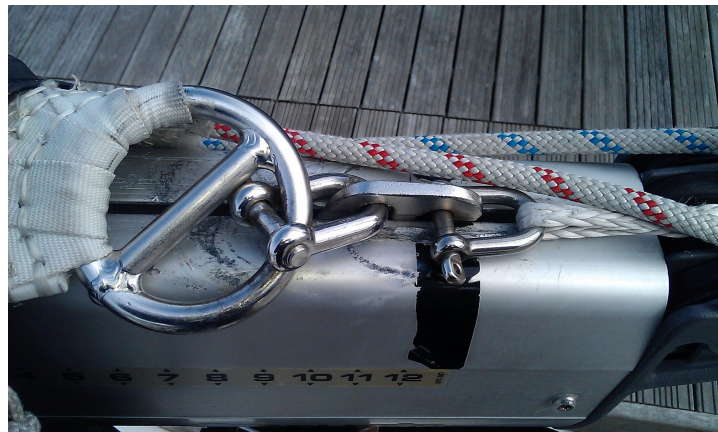
Fig. 3.1

3. Heavy wear from the outhaul shackle and mainsail clew arrangement is evident at the aft end of the boom top side as seen in *Fig 3.1*. If this were to go unchecked it would only be a matter of time before the structural integrity of the boom would be compromised.

With regards to the aft end of the boom, the damage being caused is inherent in the system that is being utilised to tension the sail foot. To avoid having to replace the boom prematurely it is recommended that a 'racing' style outhaul is used, where velcro, Dyneema and soft shackles are used in place of stainless steel fittings.
